TO: Service Locations

FROM: Technical Support Development

SUBJECT: **EPA07 MBE 900 New MCM Software v9.6.1.0 and CPC Software r3.00**

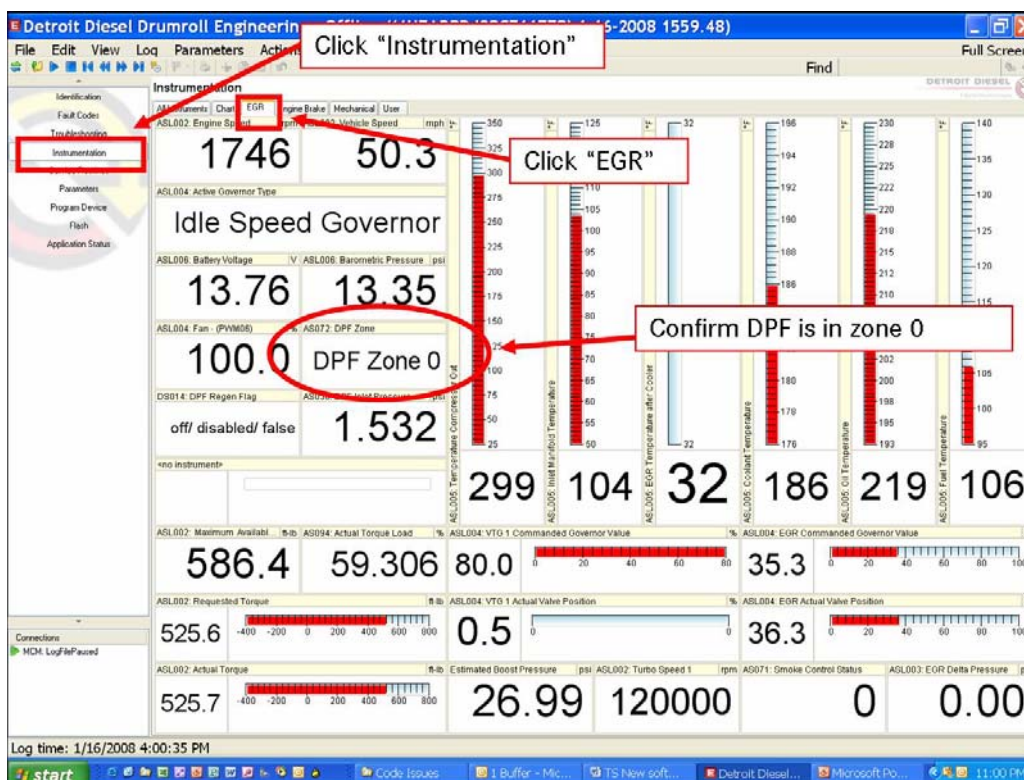
Figure 2 – DPF Zone Identification

5. If the Diesel Particulate Filter (DPF) is not in zone 0, perform a parked regeneration of the Aftertreatment System. To check the DPF zone, click on the “Instrumentation” button and then select the “EGR” tab. See Figure 2.
