# Star Motors

Specializing in 300 SEL 6.3's, 450 SEL 6.9's & 600 Limousines

# Quality New & Rebuilt Mercedes-Benz Parts Specializing in 300 SEL 6.3's, 450 SEL 6.9's and 600's

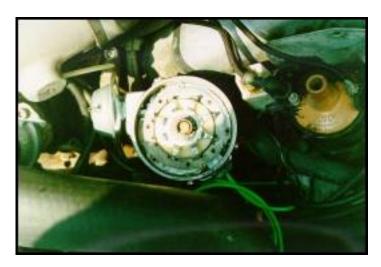
Position engine to top dead center with ignition switch. Note position of old distributor. New distributor's #1 position will be 120° clockwise from old. Remove distributor by loosening 10mm head bolt from base. Disconnect electrical wires. Pull distributor straight up. If distributor does not pull up, it is frozen. If so, heat and strike upward with a rubber mallet to loosen.

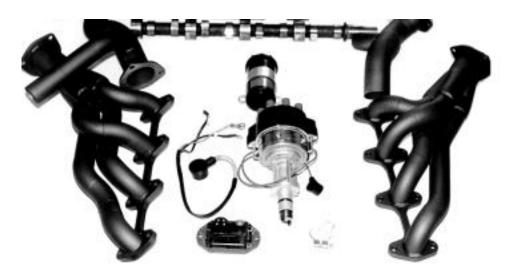
Headers, electronic ignition and camshaft.
